U.S. CHEMICAL SAFETY AND HAZARD INVESTIGATION BOARD

INVESTIGATION REPORT

VAPOR CLOUD DEFLAGRATION AND FIRE

BLSR OPERATING, LTD.

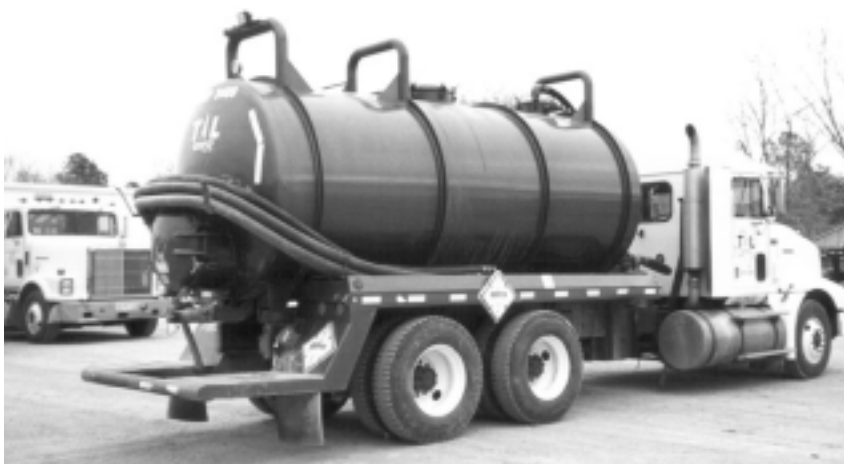
Figure 1. Typical vacuum truck used to haul oilfield waste liquids.

Figure 1 shows a typical 50-barrel vacuum truck, similar to the two that were destroyed in the January 13 incident. T&L management stated that the trucks were not authorized to transport flammable liquids; this was confirmed by truck tank manufacturing records (Section 5.4).

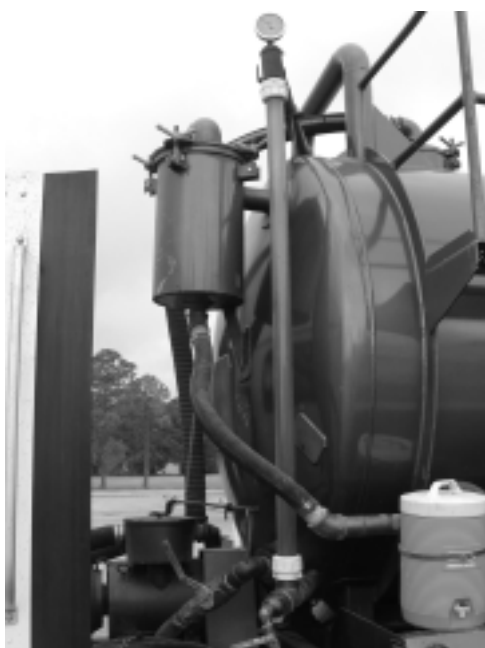
Figure 4. Typical vacuum truck tank sight gauge.

. . . The ability to avoid condensate removal is dependent on the technique the driver uses to measure the storage tank contents.

. . . There is no accurate measurement of how much condensate is included in the BS&W loaded into the trucks.

All T&L drivers and other waste hauler drivers interviewed by CSB stated that they were clearly instructed to avoid removal of condensate when removing BS&W from the storage tanks. However, the ability to avoid condensate removal is dependent on the technique the driver uses to measure the storage tank contents. Some waste hauler drivers report that they use a gauge line¹² to “color cut”¹³ the contents of the storage tank, providing an actual measurement of BS&W removed. Other drivers use the gauge line only to measure the total height of condensate plus BS&W in the storage tank before and after removal of the liquid. Some drivers use the sight gauge mounted on the truck tank (Figure 4) to estimate the amount of liquid removed from the storage tank.

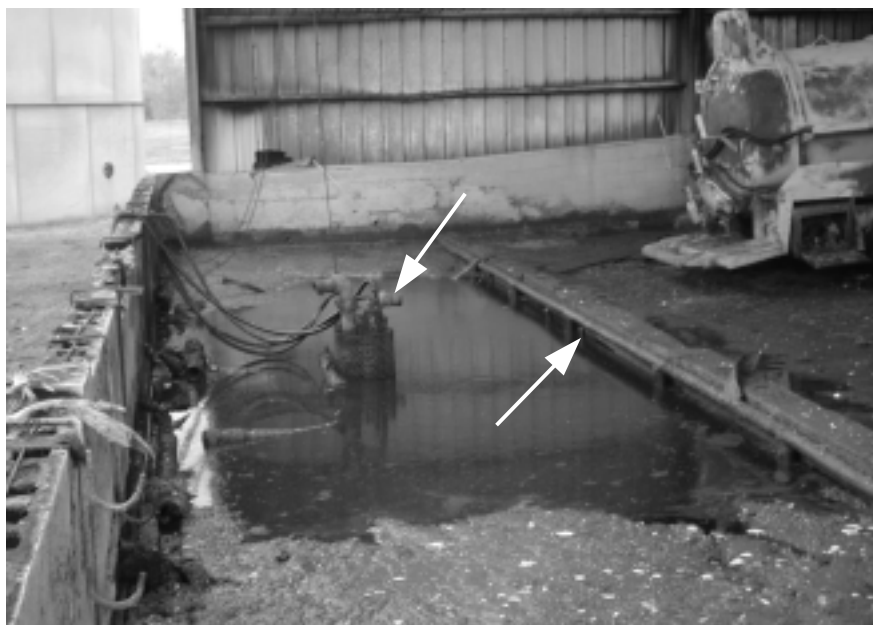
Figure 6. Pad area hydraulic sump pumps and wooden stop beam.

Two hydraulically operated lift pumps (Figure 6) transfer the waste liquids through polyvinyl chloride (PVC) pipes to an open-top waste liquid agitator tank located 40 feet west of the pad, or to the mixed water and mud holding tanks located about 70 feet south of the pad (Figure 5). Flexible hoses connect each pump to the PVC transfer pipes. Additionally, the pump discharge can be connected to a PVC header on the inside west wall of the pad to recirculate the liquid and further dilute the mud. Significant volumes of waste liquid, including potentially flammable BS&W, typically accumulate when offloading onto the concrete pad; the sump pumps have a lower flow capacity than multiple draining vacuum truck tanks.

Significant volumes of waste liquid, including potentially flammable BS&W, typically accumulate when offloading onto the concrete pad . . .

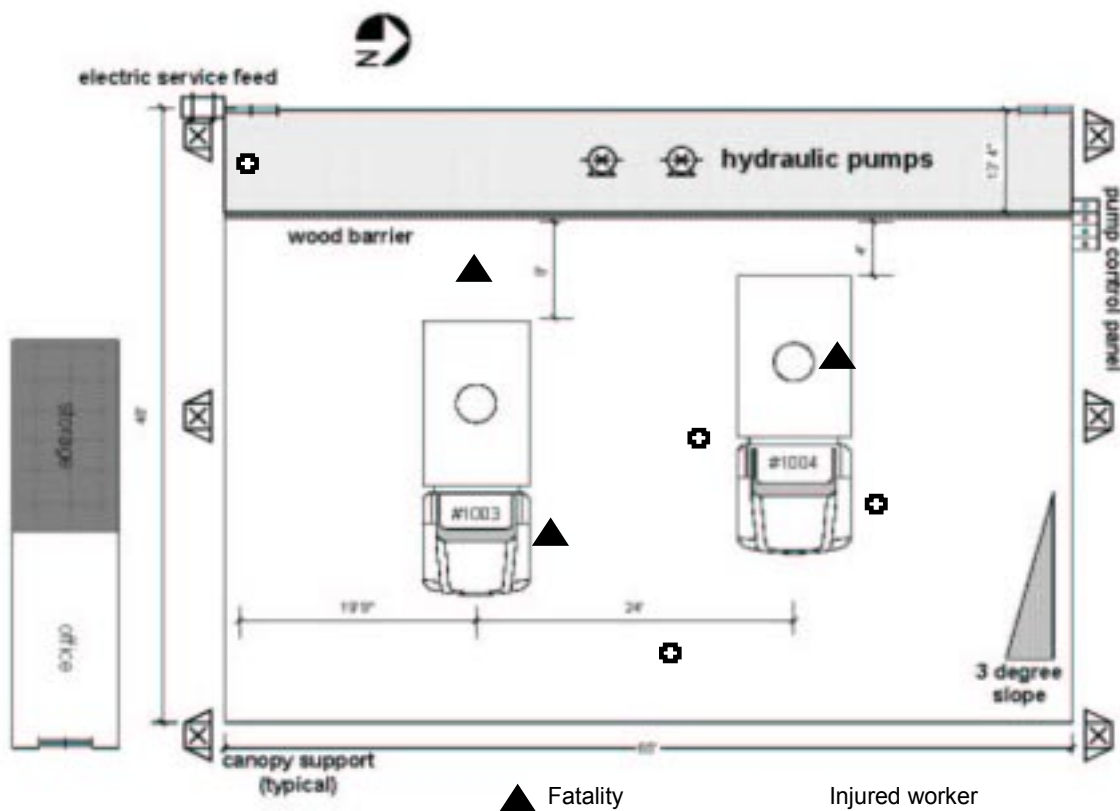
Figure 7. Layout of mud disposal and washout pad, with T&L vacuum trucks positioned as on January 13, 2003.

The mud disposal and washout pad has a 3-degree slope, to a maximum depth of approximately 20 inches (Figure 7). A 12- by 12-inch wooden beam running the length of the pad, approximately 13

The trucks arrived at BLSR within a few minutes of each other. Each driver backed onto the mud disposal and washout pad to unload BS&W and have the truck tanks rinsed out. The trucks were approximately 16 feet apart and equally distant from each side of the pad (Figure 7). Based on the service work order recovered from the drivers' shed and the vehicle license plate, the truck parked on the north side was #1004; the truck parked on the south side was #1003.

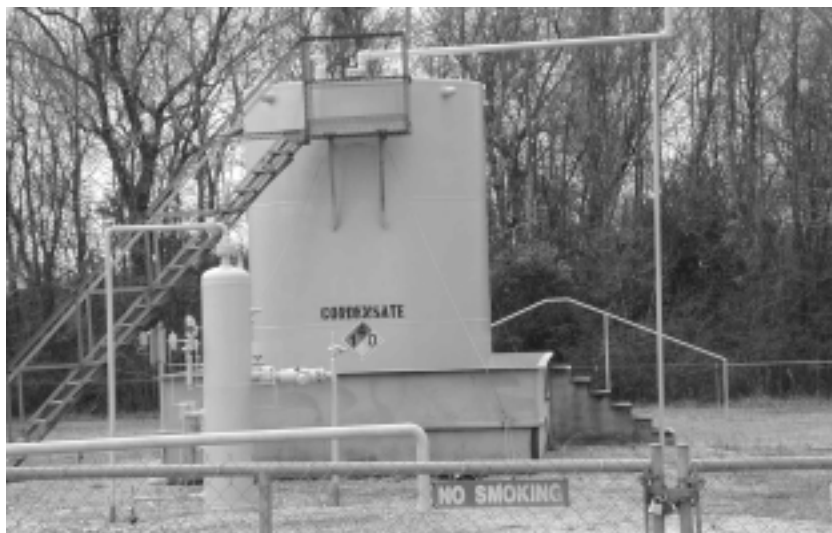
Figure 12. Condensate storage tank located at gas regulator station.

BLSR management reports that drivers have actually delivered condensate to the disposal facility when they thought they had collected water or BS&VW from a well site storage tank; they had inadvertently removed saleable product liquid by drawing from the wrong tank. Proper storage tank labeling might help prevent future occurrences of this dangerous and wasteful practice.

CSB observed that the condensate storage tanks at two gas pipeline metering stations in the area, owned by a gas transmission pipeline company, were labeled with the National Fire Protection Association (NFPA) hazard diamond displaying a flammability rating of 4 (very volatile flammable liquid; Figure 12).

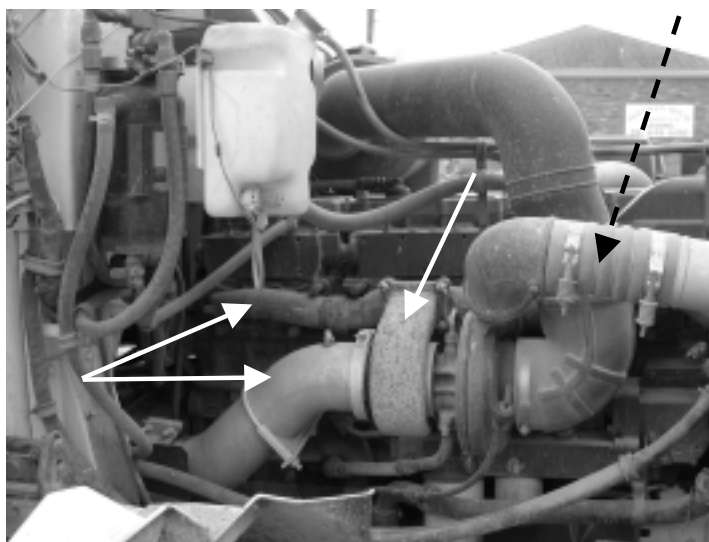
Figure 16. Diesel engine exhaust and intake system.

The T&L truck engines were not equipped with overspeed protection devices in the intake or exhaust systems. Eyewitness accounts of the over-revving are clear evidence that the air intake system was drawing in flammable vapor prior to the deflagration. Eyewitnesses reported hearing loud backfiring from one of the engines. Examination of the truck engines and debris confirmed that the metal elbow on the south truck engine (Figure 15) separated from the turbocharger housing—which is a positive indication that the engine backfired through the intake system, potentially igniting flammable vapor.

One witness also reported that the hood on the south truck lurched up just before the vapor ignited, suggesting a high-pressure impulse around the engine. The elbow and attached short piece of flexible hose (dark arrow in Figure 16) were recovered and showed no fire damage, providing further evidence that the fitting had come off and fallen to the ground before the fire ignited and destroyed the engine.³²

³²For comparison, evidence suggests that either the north truck engine did not backfire, or the pressure wave from a backfire was not sufficient to blow the fitting off the turbocharger. A portion of the elbow was still attached to the turbocharger housing, and the remainder of the elbow and flexible hose was destroyed.

A typical industrial diesel truck engine has many possible heat sources, including engine block and heads, and exhaust manifold and turbine housing (Figure 16). The engine block and heads are expected to
